ENVIRONMENTAL ASSESSMENT
TAINTER GATE CABLE REPLACEMENT
LAKE RED ROCK
MARION COUNTY, IOWA

CONSTRUCTION PROCEDURES FOR
TAINTER GATE TOUCH UP PAINTING

Red Rock Dam – Lake Red Rock Des Moines River, Iowa Tainter Gate Touch-Up Painting

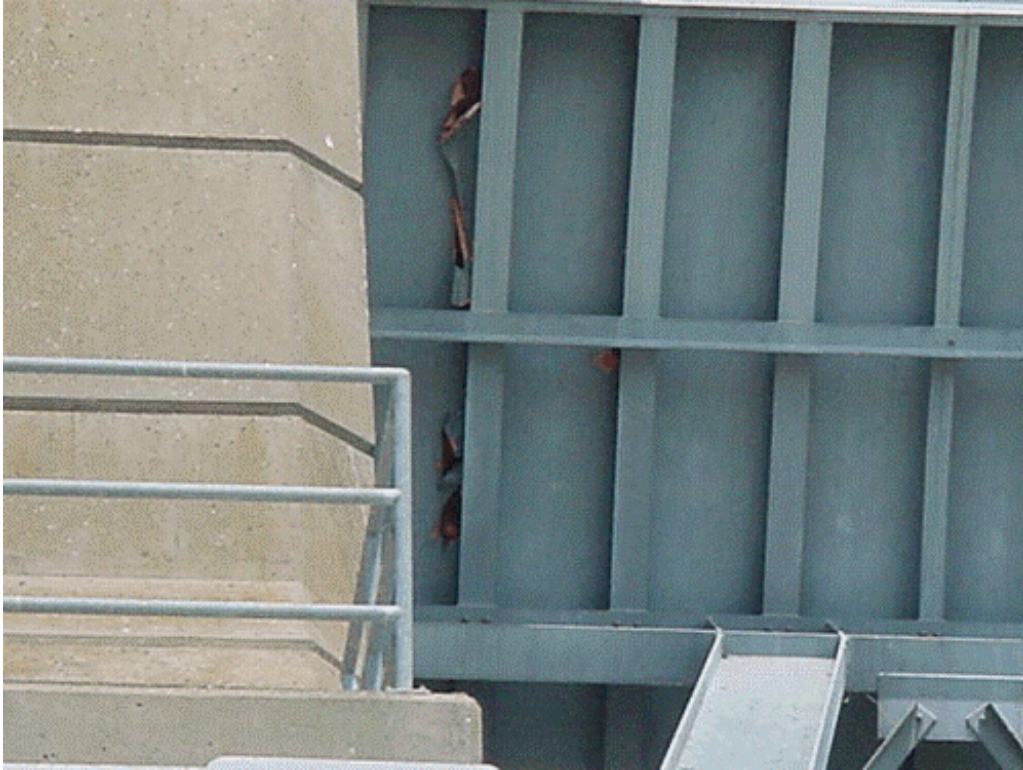
The tainter gate cables (a total of 40) were replaced in 1993. The cables have an estimated service life of 15 years, requiring that they be replaced again in 2007-2008. A drawdown of the conservation pool below the elevation of the cable connection brackets at 735 feet is necessary to replace the cables. During this drawdown, it will be possible to do touch-up painting on the vinyl paint system currently on the tainter gates. During a 2002 periodic inspection, it was found that although the overall the paint system, applied in 1989, is in fair condition; there is some blistering and peeling of paint on the downstream sides of the tainter gates as shown in Figure D1. Rehabilitation of the paint system at areas where blistering or chips have occurred would help to preserve the metal underneath, as well as extend the life of the entire paint system.

Figure D1. Downstream side of Tainter Gate 5 showing blistering paint at the far left of the gate.

Rehabilitation of the vinyl paint system would involve touch-up painting. The process would include sand blasting of the affected areas down to bare metal, applying a primer, and then applying the vinyl paint coating system either by spray or by hand. The paint should not be applied at temperatures below 35°F, without significant measures to mitigate for temperatures at or below freezing. A containment system would have to be constructed at each touch-up paint location to collect excess sand and paint. The last maintenance painting project in 1989, in which the current vinyl paint coating system was applied, included removal of the existing lead based paint on the tainter gates. Therefore, there are no lead based paint removal requirements for touch-up painting or any future painting applications on the tainter gates. It is estimated that complete repainting of the gates and accompanying machinery would take at least 3+ months if the contractor works two shifts, 6 days a week. The touch-up painting is estimated to take 1.6 months (within the timeframe of the proposed 2007 fall drawdown) with a similar schedule, but the time would greatly depend on the number of affected areas that would need rehabilitation. These estimates assume good weather and no delays to the contractor.
